# Manhole Inspection Summary

Manhole # S37SS\_002MH

**Location** Address: **2614 BOONE ST**

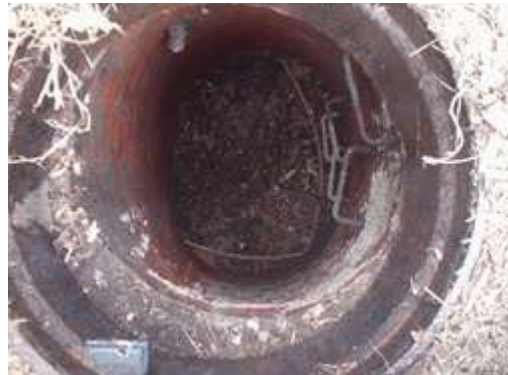
Top View

Channel debris.

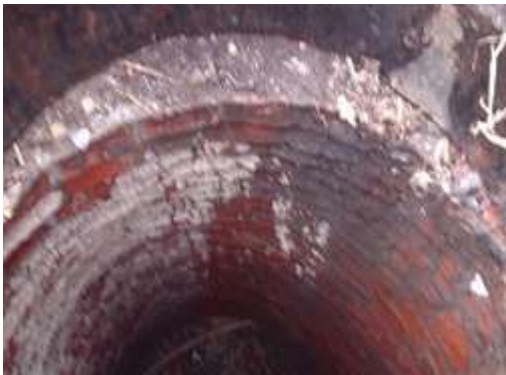
Defect

**Frame** Offset: **4** (in.) Condition: ☒ Sound ☐ Cracked ☐ Leaks

Condition: ☐ Sound ☐ Cracked ☐ Root Intrusion ☐ Loose Brick ☒ **Deteriorated**

Infiltration: ☐ None ☒ **Joint** ☐ Cracks ☐ Mortar ☐ Roots ☒ **Wall**

Infiltration: ☐ None ☐ Joint ☐ Cracks ☐ Mortar ☐ Roots ☒ **Wall**

Frame offset. Adjustment deterioration and infiltration. Barrel infiltration.

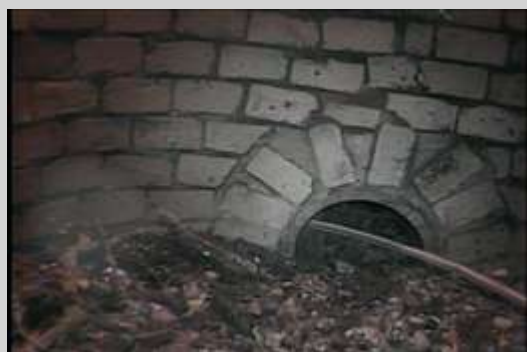
Pipe Out @ 12 O'Clock

Deposits: ☐ None ☒ **Mud** ☐ Sludge ☒ **Debris** ☐ Grease

Silt Depth: **2** (in.)

Infiltration: **Evidence**
